# **Seismic Assessment of Unreinforced Masonry Walls**

**A thesis  
submitted in partial fulfillment  
of the requirements for the Degree  
of  
Doctor of Philosophy  
In Civil Engineering  
by  
Ludovikus Sugeng Wijanto**

**Department of Civil Engineering  
University of Canterbury  
Christchurch, New Zealand**

**December, 2007**

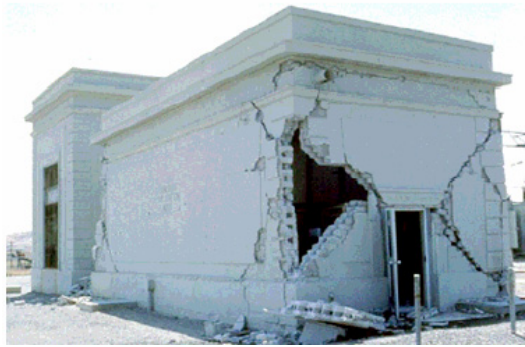
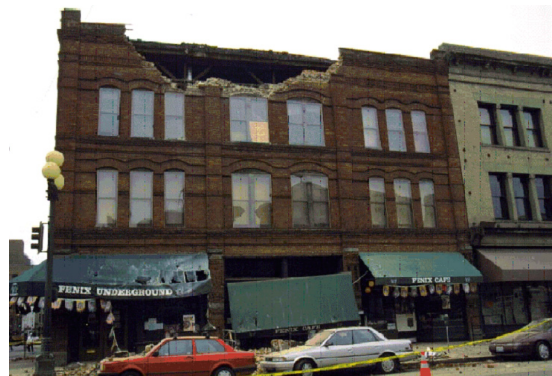
Figure 1.1. Severe damages at URM buildings after an earthquake

(a) Coalinga earthquake May 2, 1983

(f) Nisqually earthquake February 28, 2001

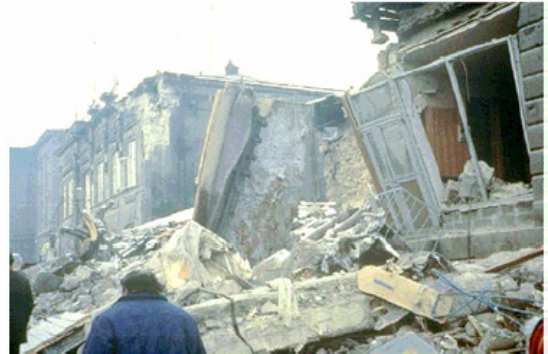
(b) Armenia earthquake December 7, 1988

- An earthquake of December 7, 1988, having a magnitude of 6.8 struck the Soviet Republic of Armenia. Cities such as Spitak and Leninakan suffered heavy damage.

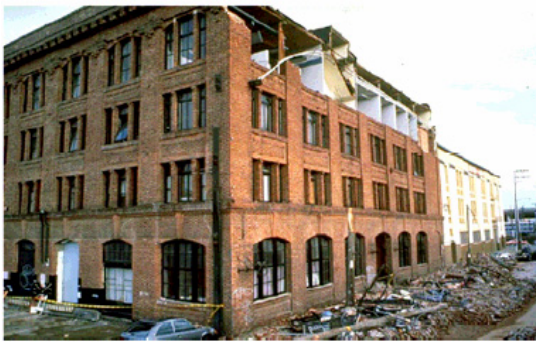
(c) Loma Prieta earthquake October 17, 1989

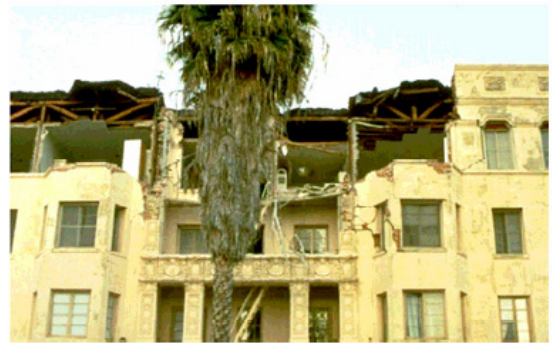
(d) Northridge earthquake January 17, 1994

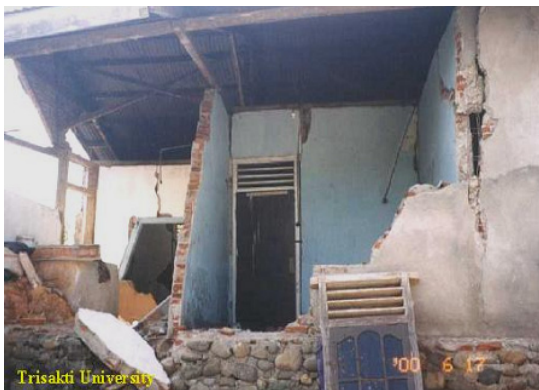
(e) Bengkulu earthquake –Indonesia  
June 4, 2000

- A large number of the earthquakes in Indonesia have caused extensive damage to unreinforced masonry housings. The houses commonly consist of a half clay brick thickness and are constructed in accordance with common local practice without design for earthquake resistance. However, older masonry buildings with more than one wythe performed well suffering only minor or no damage at all when subjected of low to moderate earthquakes.

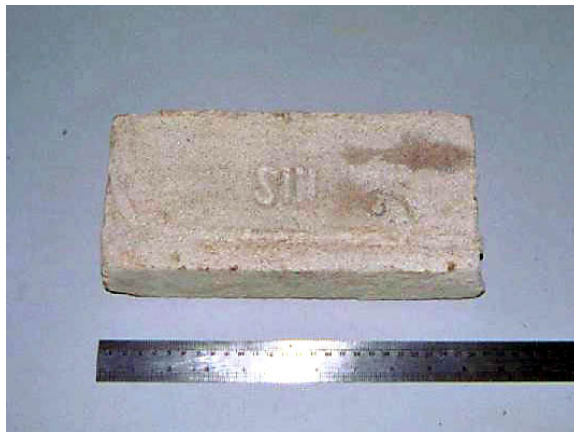
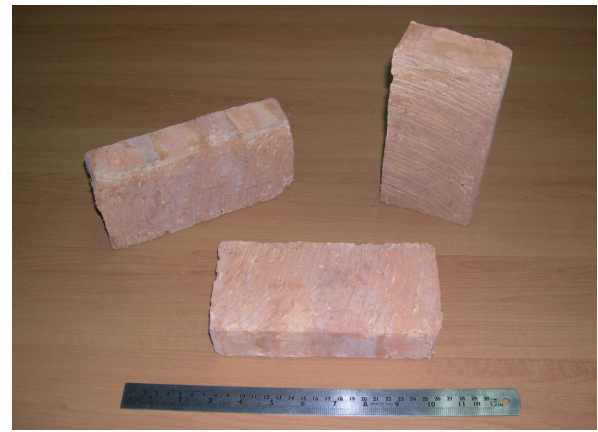
(a) Old clay-brick

(b) “HSG” clay-bricks

Figure 3.2. Comparison between old clay-brick and “HSG” clay-bricks

The results of these tests indicate that the shape and colour of the bricks vary greatly, and the HSG-brick average dimension is 189 mm length x 90 mm width x 47 mm thick, with coefficient of variation 1.36 %, 2.02 % and 3.07 % respectively. This average masonry unit dimension confirm to the 75% scale compare to original clay brick dimension that is used in the original building. The original clay brick average dimension is 256 mm length x 121 mm width x 53 mm thick. Figure 3.2. is shown the picture of the original clay brick that was used in the existing buildings and HSG clay brick.

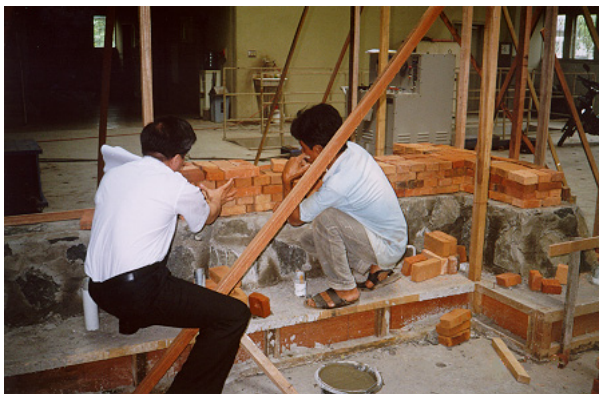
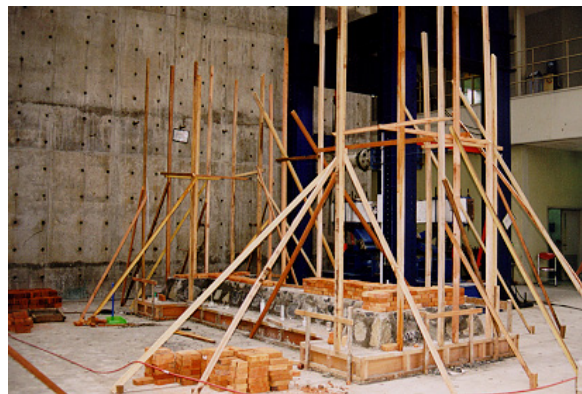
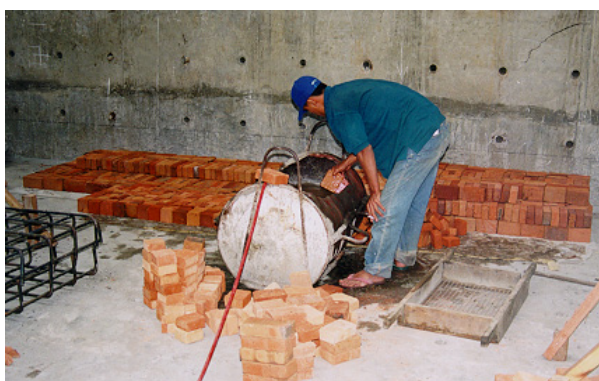
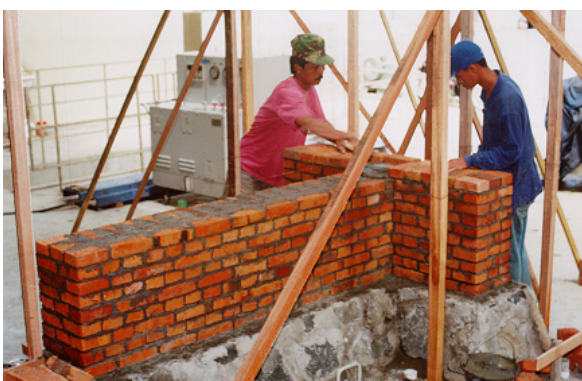
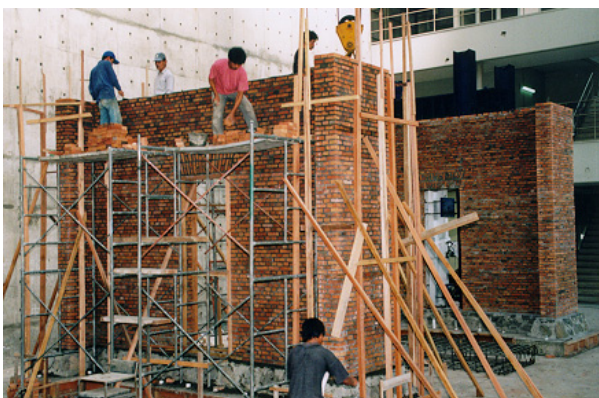
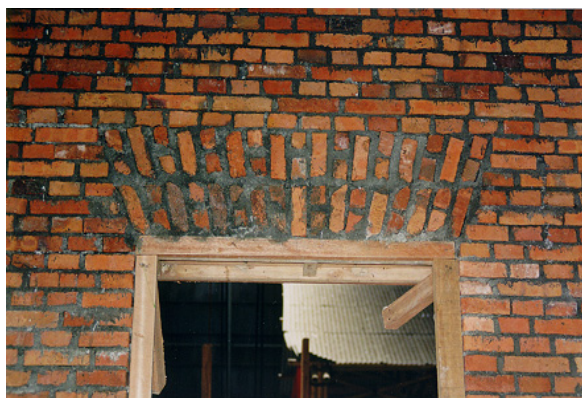
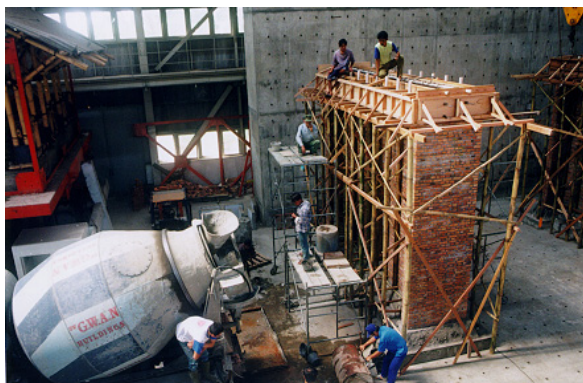
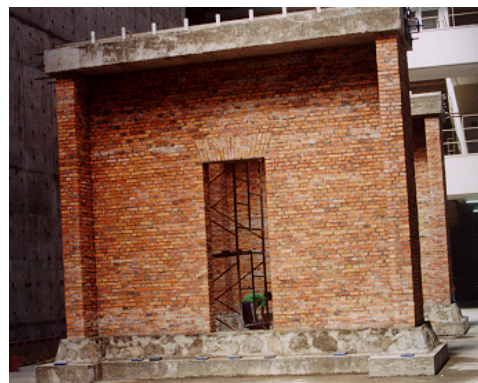
(a) Instruction on Dutch Bond configuration

(b) Initial stage of constructing URM Unit-2

(c) Soaked for 5 to 8 minutes in a water tank

(d) Progress on URM Unit-2

(e) Final brick layer for URM Unit-1

(f) spandrel brick above the door opening

(g) Concreting the top beam

(h) Final stage of URM Unit-1 and Unit-2

Figure 4.7. Erection stages of URM wall Unit-1 and Unit-2

The laying of the clay-bricks was started by making a sample piling of 4 courses without the use of mortar. This was done to allow the local professional masons to become familiar with the Dutch Bond and 1½-wythe clay brick system to be used. These four courses will be the standard method, which was of upwards-repetitive character. To better clarify the operation, each mason was provided with a Dutch bond configuration drawing as shown in Figure 4.2. The four masons were divided into two groups to build the masonry wall of model unit-1. The first group erected the wing on the left hand side of the door opening and the other group on the right hand side of the door opening. Two assistants carried out mortar mixing. Mortar consists of 1 part of Portland cement to 4 parts of sand, and measuring of the composition was done by volume. All clay-brick units were first soaked for 5 to 8 minutes in a water tank. Thickness of the bed joint and header joint was controlled at an average of around 10 mm. The technique for maintaining the straightness of the masonry wall and plumbness, a set of guide timber trusses were made around the concrete block and a string was placed at each layer of clay-brick to control the thickness of bed joints (see Figure 4.7.b. and 4.7.d.)

in the centre part 6 pvc-sleeves of 2-inches diameter were placed horizontally to a length of 5450 mm. These pvc-sleeves were used to connect the steel base-plate on the front part of the hydraulic jack with the steel base-plate on the other end. This was carried out to ensure that the lateral distributed load worked evenly on the whole longitudinal upper surface of the masonry wall from the concrete block above the wall when a push-pull hydraulic jack was applied. A pvc-sleeve of 2-inches diameter in the vertical direction was made available for the installation of four pairs of VSL thread-lock bars. The upper concrete block for the two unit-models were placed simultaneously with ready mix concrete grade  $f'_c = 20$  MPa. Timber formwork was used to support the concrete block during placing of the concrete. Three concrete cylinders of 150 mm diameter and 300 mm height were taken during placing for testing of the concrete at 28 days age. Some pictures taken during the erection stages of the URM Wall Unit-1 and Unit-2 were shown on Figure 4.7.

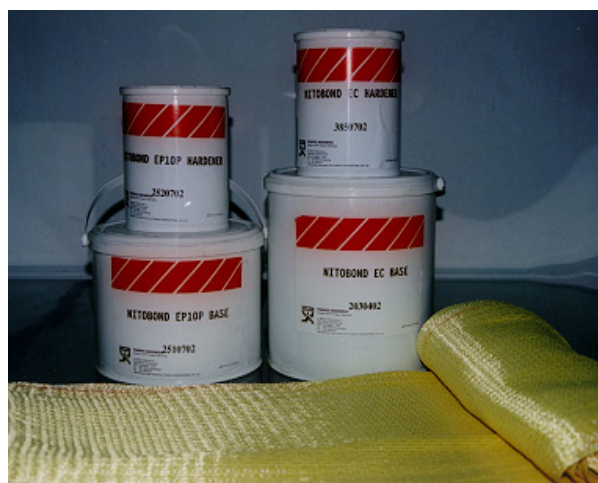
Figure 4.8. Strengthening materials : Kevlar-fibre, Nitobond-EP10P and Nitobond-EC

Figure 4.8. was shown the strengthening material. Figure 4.9. and 4.10. were shown the installation progress of strengthening materials at URM Wall Unit-2.

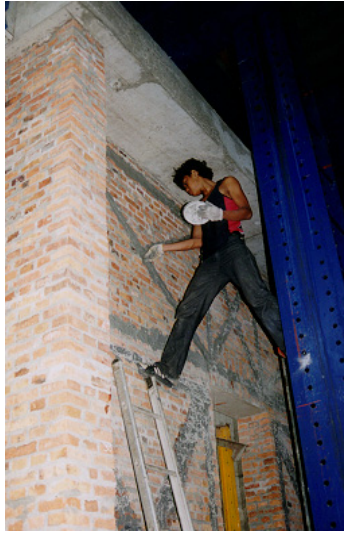
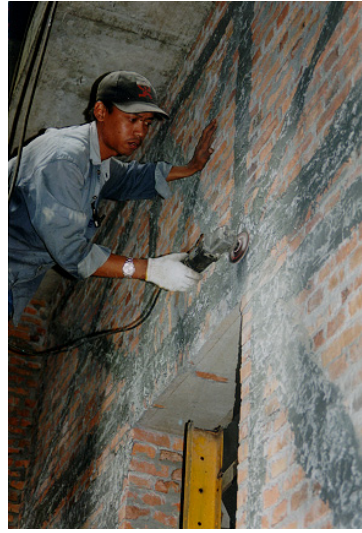
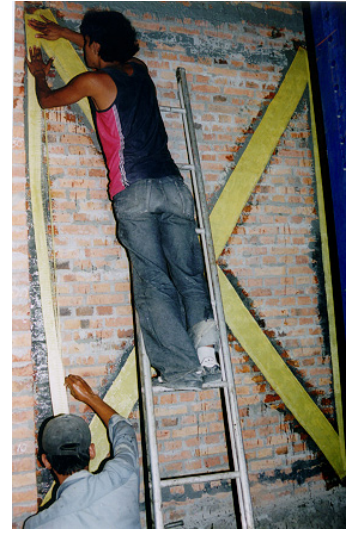
(a) Installation of Nitobond-EP10P as priming surfaces

(b) surfaces levelling by grinding prior installation of Kevlar fibre

(c) Installation of Kevlar fibre

Figure 4.9. The installation of strengthening materials at URM Wall Unit-2

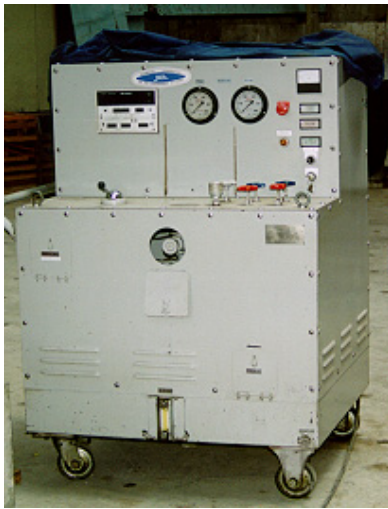
(c) Hydraulic pump unit type L-3-7

Figure 4.12. Various test equipments

Various measuring equipment were used for the tests of both URM wall specimen as shown in Figure 4.12. The equipment was calibrated and adjustments to the correction factors were made. The following measuring equipment was used:

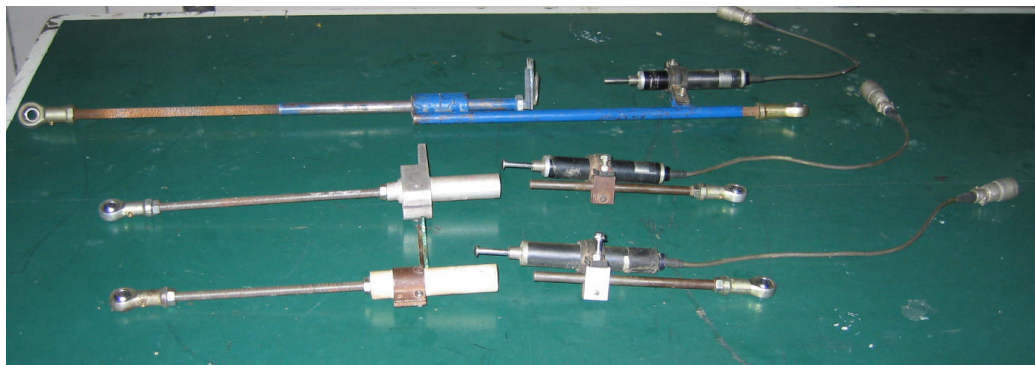
(e) Diagonal transducers ( LVDTs )

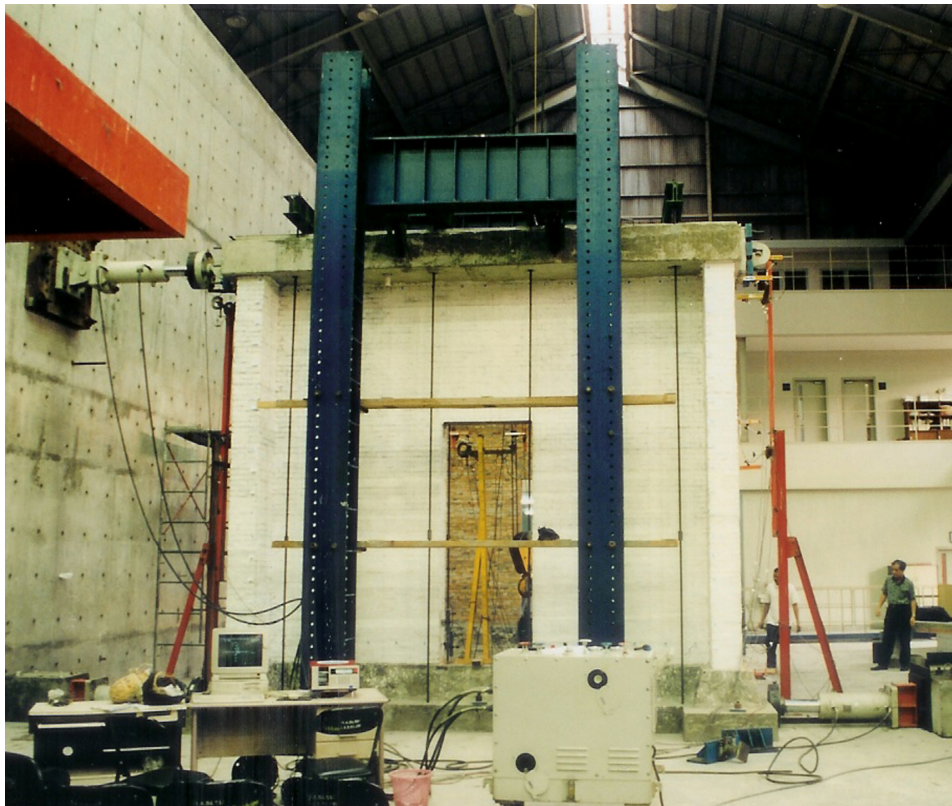
Figure 5.1. Test arrangement of URM wall Unit-1

The applied loading history was described in detail in Section 4.8 of Chapter 4. The test results are reported in this Chapter, including its crack pattern, lateral force-displacement response, pier behavior, and the estimated energy dissipation.

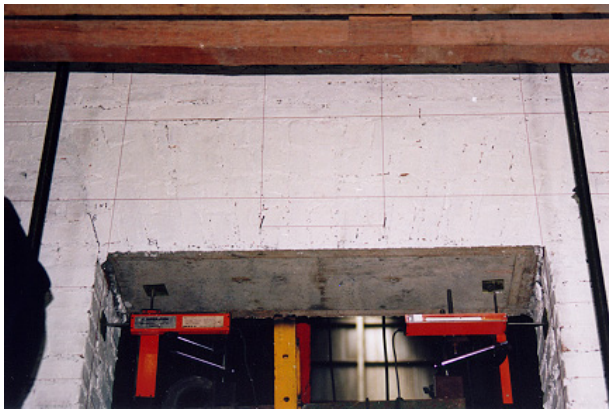
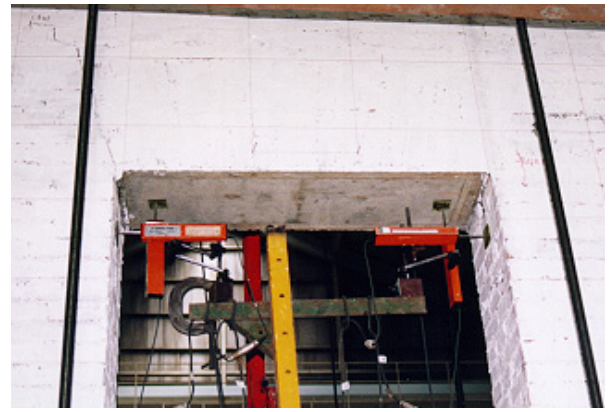
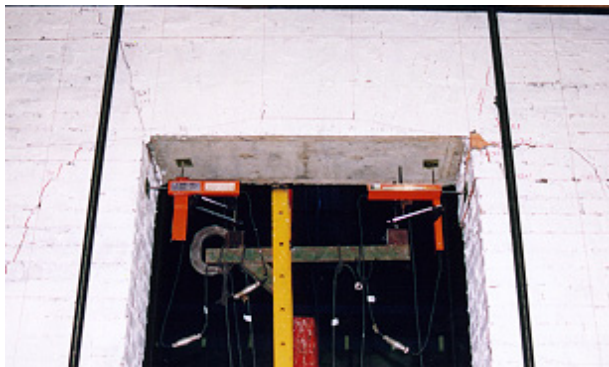
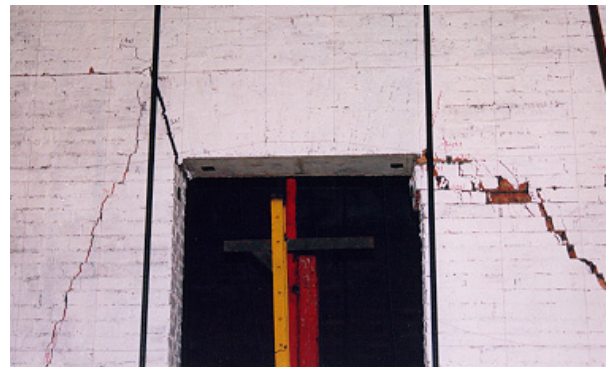
(a) Lateral displacement = + 1.0 mm

(b) Lateral displacement = + 1.4 mm

(c) Lateral displacement = + 10 mm

(d) Lateral displacement = + 15 mm

The test result of URM-wall Unit-1, which represents the existing building, was very satisfactory. An overview of the crack histories is given in Table 5.1. and the final crack pattern after the test was shown at Figure 5.2. This final crack pattern was shown at the back side from LVDTs position as shown in Figure 4.14. The first cracking happened at a + 1 mm lateral displacement at the top of the URM-wall (storey drift = + 0.025%). A small crack started at the header joint between the flat arch brick and the horizontal brick course was observed at the left side of the spandrel above the door opening. The left flanged wall contributes additional stiffness in tension and a small horizontal crack at the bed joint appeared at the one fourth from the pier height. The crack at the left side of the spandrel extended at the next stage of positive lateral displacement in the joint between the flat arch brick above the door opening. In the reverse lateral displacement, a bed joint crack also appeared at one course below the right of the spandrel above the door opening. It was indicated that flexural behaviour still dominated and the spandrel behaved as a coupled beam. As shear cracks developed in the joint between the spandrel and both piers, the pier capacity was decreased.

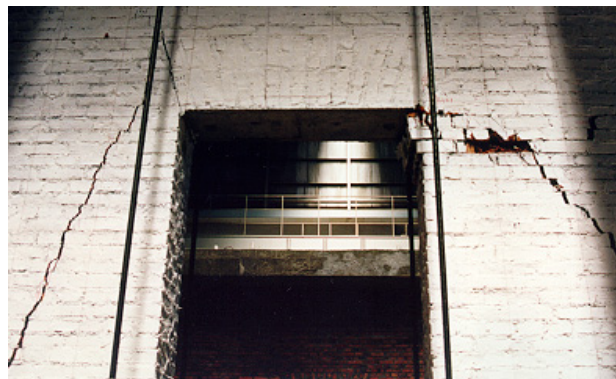
Figure 5.3. Crack pattern above door opening at flat arch for URM wall Unit-1

(e) At the end of the test

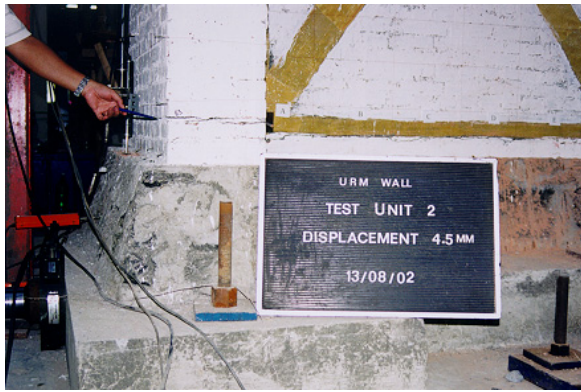
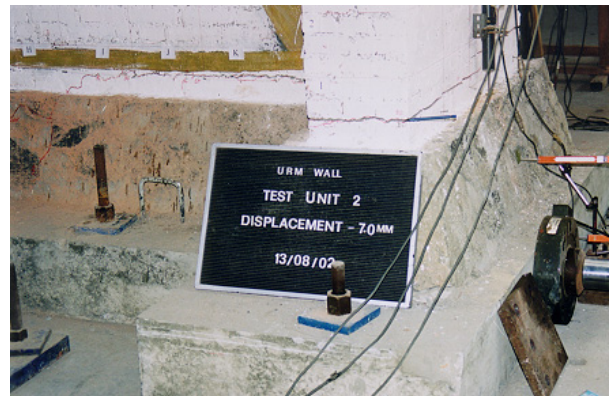
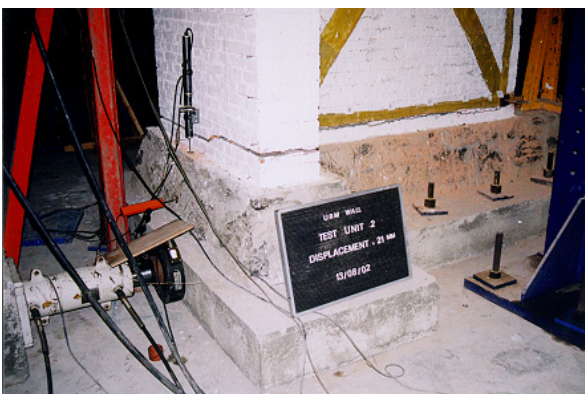
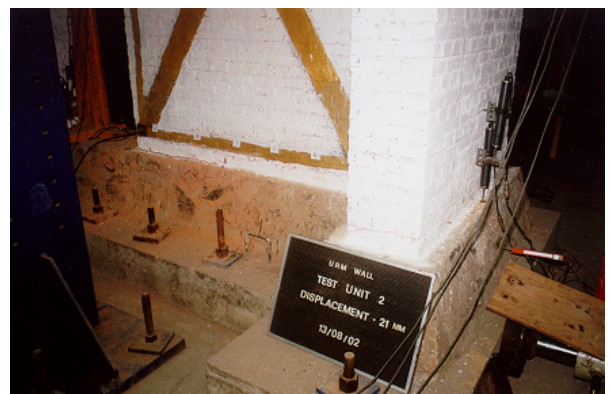
(a) Lateral displacement + 4.5 mm

(d) Lateral displacement - 7.0 mm

(e) Lateral displacement + 21.0 mm

(f) Lateral displacement - 21.0 mm

URM wall Unit-2 responded very well during the testing and the influence of the strengthening could be seen fairly clearly by the increased capacity of the unreinforced masonry wall in resisting the lateral shear load. It was clear the performance of URM-Unit 2 during the test was dominated by a rocking mode. A brief description of the test results for URM wall Unit-2 is presented in Table 6.1. It presents a summary of crack histories during the selected test runs, top lateral displacements of the URM wall and drift values. The final crack pattern after the test was shown at Figure 6.2. This final crack pattern is shown on the reversed side from the LVDTs position is shown in Figure 4.16. The results are also discussed in the following paragraph.

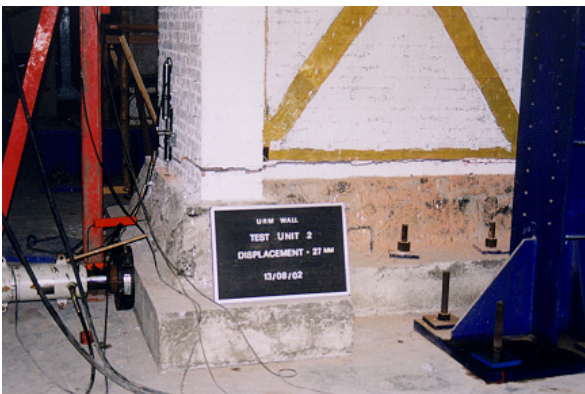
Figure 6.3. Cracks on the bottom of both piers of URM Wall Unit-2

(g) Lateral displacement - 27.0 mm

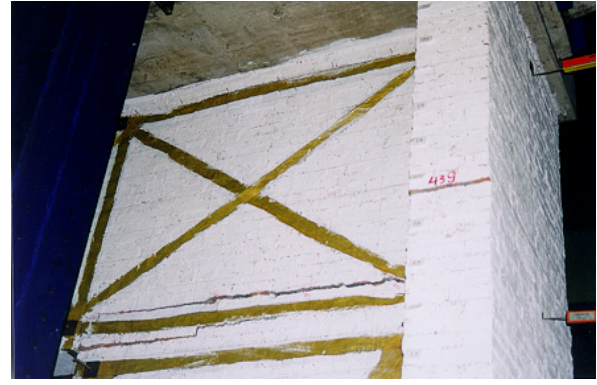
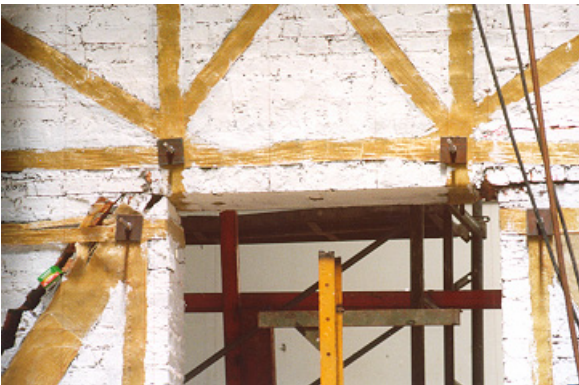
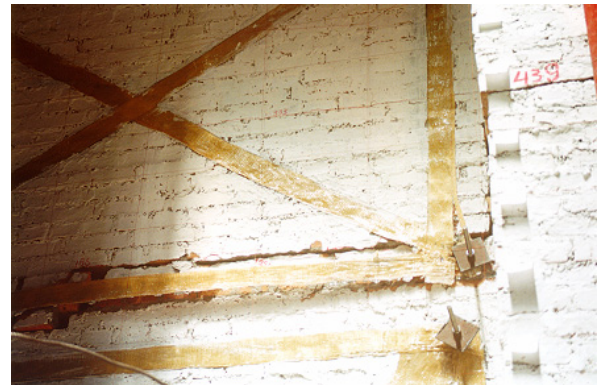
Figure 6.4. Cracks due to rocking at upper part for URM Wall Unit-2

(c) Crack above door opening and Kevlar Fiber was torn along with the fiber direction

(d) Bed joint cracks at upper part and Kevlar fiber delaminated

(e) Crack penetrate at both sides along the right upper part wall

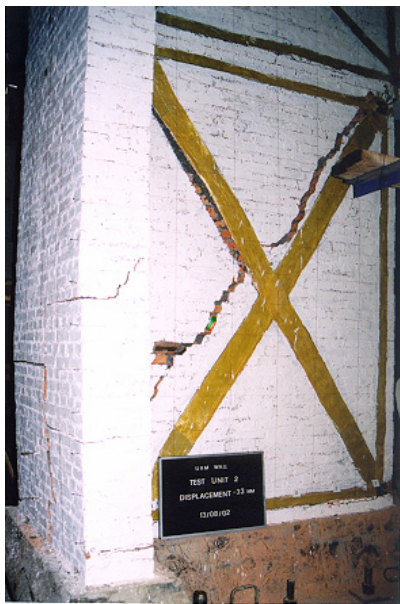
(b) 36 mm crack width

The diagonal tension crack on the right pier appeared	39 (770)	+ 27.0	+ 0.664
Diagonal Kevlar at the right pier was delaminated and the clay brick unit was splitting surrounding the epoxy layer.	41 (850)	+ 33.0	+ 0.814
Kevlar joint at the right top of the left pier was torn along with the fiber direction and delaminated. The diagonal tension crack occurred in the left pier with 36 mm crack width. The test was stopped	42	- 33.0	- 0.814

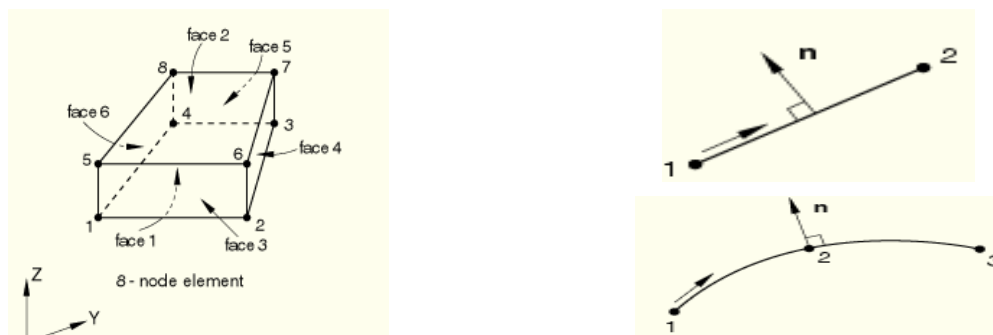
(a) Tetrahedral element faces – 8 nodes      (b) Truss elements – 3 dimensional and 2 nodes

Figure 8.2. Continuum element and Truss element (Hibbit et al., 2004)

Macro modeling in three dimensional analyses was carried out using the finite element ABAQUS and the 8-node continuum elements was used to model the URM-walls in this thesis. The element has six degrees of freedom at each node. The Kevlar material in the second URM wall was modeled by truss elements. Both element types are shown in Fig. 8.2.
